TECHNICAL SERVICE BULLETIN

Bulletin Number **08/03**
Issue Date: 26 February, 2003

Subject/Concern: BONNET LATCH ADJUSTMENT

Models: BA Falcon built before December 2002

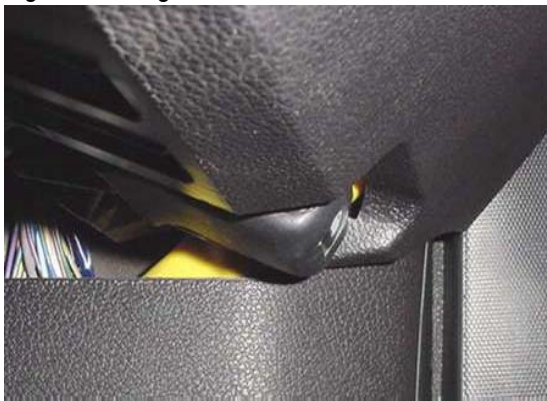
Cause: Bonnet release cable length may be excessive.

If the bonnet release handle requires more than 50% of travel to release bonnet, then follow the service action outlined below.

Figure 1 (Release handle in home position)

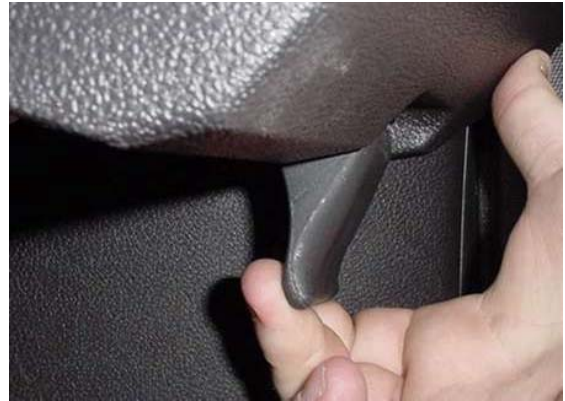
Figure 2 (Release handle at maximum travel)

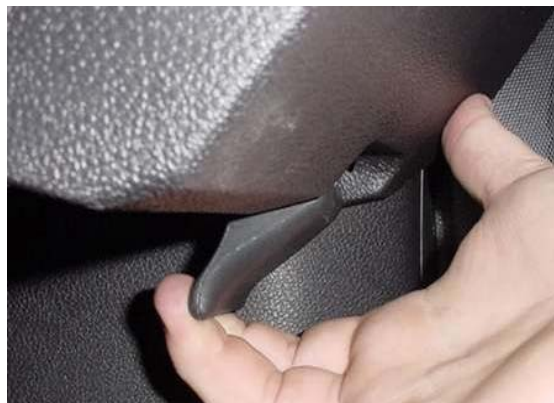
Figure 3 (Release handle in desired "release" position)

When adjustment is completed install the bonnet latch and test the travel on bonnet release handle. If the bonnet release handle operates at approximately 50% of travel then adjustment has been completed.
